**FAILURE ANALYSIS OF DIE BOND ADHESION FAILURES
CAUSED BY SILICONE CONTAMINATION**

D.T. Rooney, J.B. Dixon, and N.T. Castello

**Oneida Research Services, Inc.
One Halsey Road
Whitesboro, NY 13492**

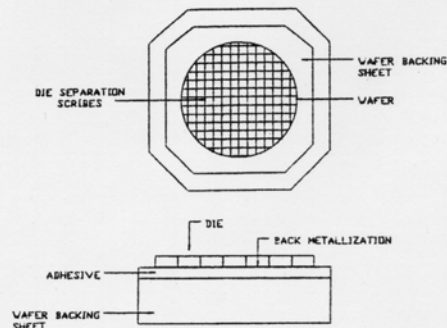
Figure 1.a: The wafer was mounted on the wafer backing sheet for die separation and pick and place

Figure 1.b: Die shear testing was performed on conductive epoxy die attaches to PCB coupons

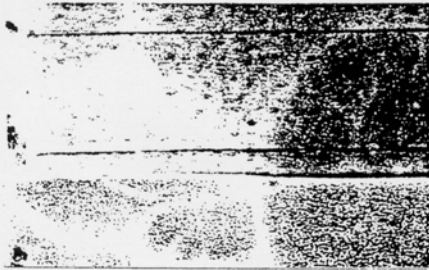
Figure 2.a: Light micrograph of wafer backing sheet and die back metallization

Figure 2.b: FLM of back metallization on die shear failure

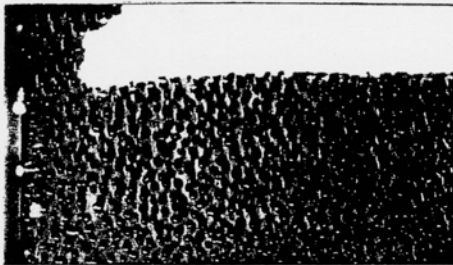
Figure 3.a: FLM of wafer backing sheet and die back metallization

Figure 3.b: FLM of residual epoxy on PCB coupon

The residual epoxy fillet on the PCB coupon contained a thin film of material which was different from the bulk epoxy, Figure 3.b. The exact nature of this film is not completely understood. One explanation is that the film was created by the segregation of the resin component from the conductive epoxy matrix. This type of segregation has been observed to cause high contact resistances in conductive epoxy die attaches.⁹ On the other hand, the film may have been a product of a reaction between the residual adhesive on the die back metallization and the die attach epoxy.

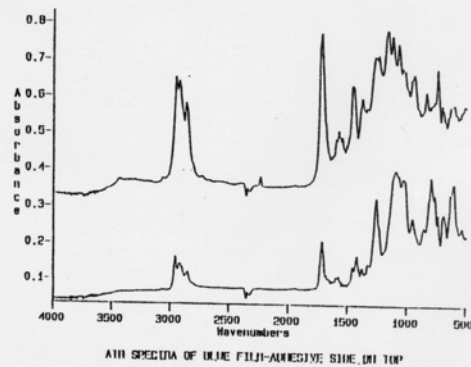
In the analysis of the die shear failures, the thickness of the residual material on die back metallization was insufficient for analysis in the reflectance mode. The film observed on the residual epoxy fillet was better analyzed by Auger, XPS, or static SIMS. However, the wafer backing sheet was ideally suited for analysis in the Attenuated Total Reflection (ATR) mode, Figure 4.a. The depth of analysis in an ATR experiment depends on the refractive index of the sample and is typically 10-20 microns (80 micron wafer backing sheet thickness). Spectra were collected on the adhesive side and the PVC side of the sheet, Figure 4.b. The spectrum of the PVC side is indicative of a mixture of plasticizers and PVC. The spectrum of the adhesive side (plotted on top), exhibited peaks at 2150cm^{-1} and 1740cm^{-1} which were assigned as a nitrile and an ester, respectively. Esters are commonly used in acrylic adhesives. Silicone peaks are not readily apparent in the spectrum of the adhesive side. This is not surprising given the

small amount of adhesive on the sheet and spectral overlaps with other materials in the adhesive.¹⁰ The presence of silicone in the wafer backing sheet adhesive was verified in the XPS analysis.

Figure 4.b: FTIR spectra of wafer backing sheet adhesive (top) and PVC sheet material without adhesive (bottom)

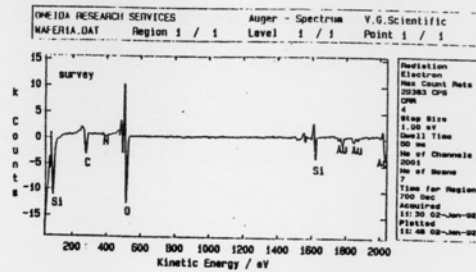
Surveys of the die back metallization display high levels of silicon contamination, Figure 5.a. XPS analysis showed that the silicon was present in the form of a silicone.

Figure 5.a: Auger elemental survey of back metallization on die freshly peeled from wafer backing sheet

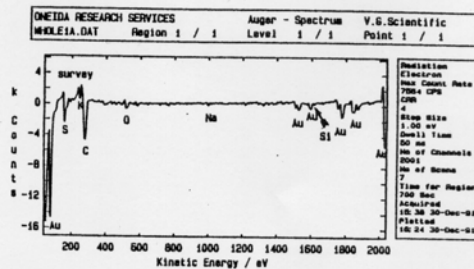
Surveys of voids in the die back metallization exhibit silicon in an oxide form. The silicon in the voids is associated with the exposed die material. Surveys of representative areas of the die back metallization which had continuous plating coverage displayed low levels of silicon near or below the detection limit, Figure 5.b.

Figure 5.b: Auger elemental survey of back metallization on die shear failure

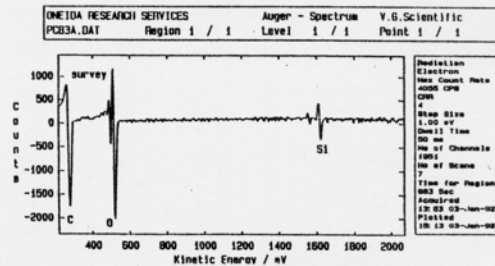
Surveys collected on the residual epoxy displayed high levels of carbon, oxygen, and silicon, Figure 5.c. The residual epoxy contained much higher levels of silicon than the die back metallization, Figure 5.b. This indicated that the silicon had preferentially adhered to the epoxy. The silicon may have been chemically bonded to the epoxy.

Figure 5.c: Auger elemental survey of residual epoxy on PCB coupon

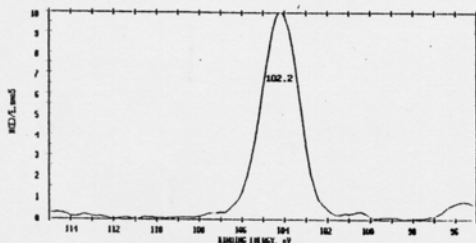
An XPS multiplex of the silicon 2p peak collected on wafer backing sheet adhesive is shown in Figure 6.a. The energies of the silicon 2p photoelectron and Auger transitions were found to be at 102.5 eV and -355.2 eV, respectively, following applications of the appropriate charge corrections. This indicated that silicon was present in the form of a silicone. Silicon was also present as silicone on the other samples listed in Table I. Silicates and elemental silicon exhibit peaks at 103.4 eV and 99.5 eV, respectively.

Figure 6.a: XPS multiplex of wafer backing sheet adhesive, silicon 2p peak

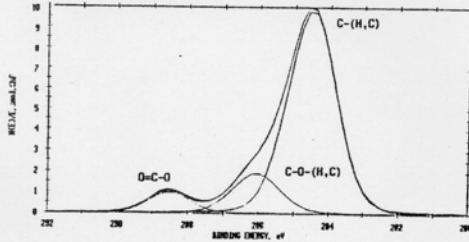
The curve fitting of the carbon multiplexes provided additional information on the chemistry of the die shear failure interface and the adhesive from the wafer backing film. Carbon was primarily present as hydrocarbons in all of the samples. Esters were observed such that equal areas of *O=C O (~288.5 eV) and O=C O* (~286 eV) are required. Any excess area at 286 eV is due to ethers and/or alcohols which are indistinguishable by XPS. The presence of esters can be indicative of hydrocarbon degradation. The acrylic adhesive is another source of ester(s). The curve fits of the wafer backing sheet and the freshly peeled die exhibit a significant amount of esters, Figures 7.a and 7.b. The presence of esters was confirmed by the FTIR spectrum of the wafer backing sheet.

Figure 7.a: XPS multiplex of adhesive on wafer backing sheet, carbon 1s peak

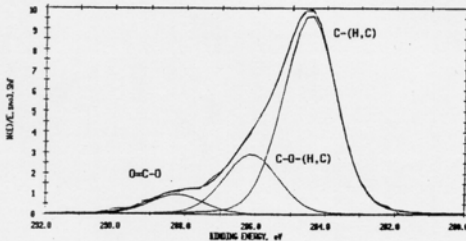
Figure 7.b: XPS multiplex of die back metallization, freshly peeled die, carbon 1s peak

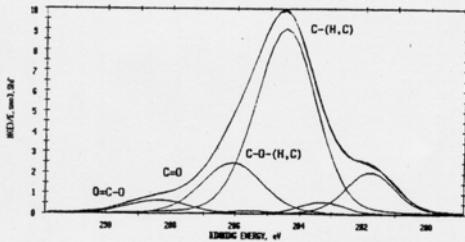
The XPS analysis of the die back metallization on the die shear failure showed the presence of a carbonyl, C=O (~287.7 eV), Figure 7.c. The relative amounts of ketone versus ester indicated by the peak fits should be viewed with caution due to the poor spectral resolution. However, the amount of ketone plus the amount of ester relative to other forms of carbon is more certain. The absence of a ketone in the wafer adhesive indicates that the source of the carbonyl is probably from the conductive epoxy. It is likely that some epoxy did adhere to the die back metallization and that the weak-boundary layer contained silicone contamination and die attach epoxy. Therefore, the silicone contamination and the conductive epoxy may have reacted to form the weak boundary layer.

Figure 7.c: XPS multiplex of residual epoxy on PCB coupon, carbon 1s peak

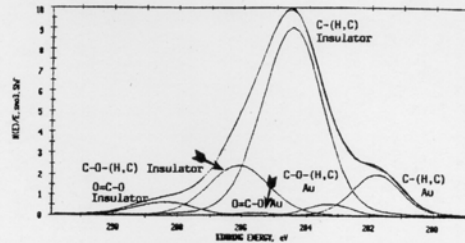
The curve fit for the residual epoxy on the PCB exhibited six bands, Figure 7.d. A logical explanation is that these are actually two sets

of three bands. The three bands in each set are due to typical carbon species. One set arises from photoelectron emission of carbon atoms on an insulator, and the other is from carbon atoms on the gold flakes in the conductive epoxy matrix. This interpretation assumes that the same type of material is present on both areas. The material on the gold experiences less sample charging than the material on the insulator so the XPS peaks of material on the gold are observed at lower binding energies.

Figure 7.d: XPS multiplex of residual epoxy on PCB coupon, carbon 1s peak
